Outline of Presentation

Managing coastal erosion – changing paradigms

Coastal erosion at Russell (quick overview!)

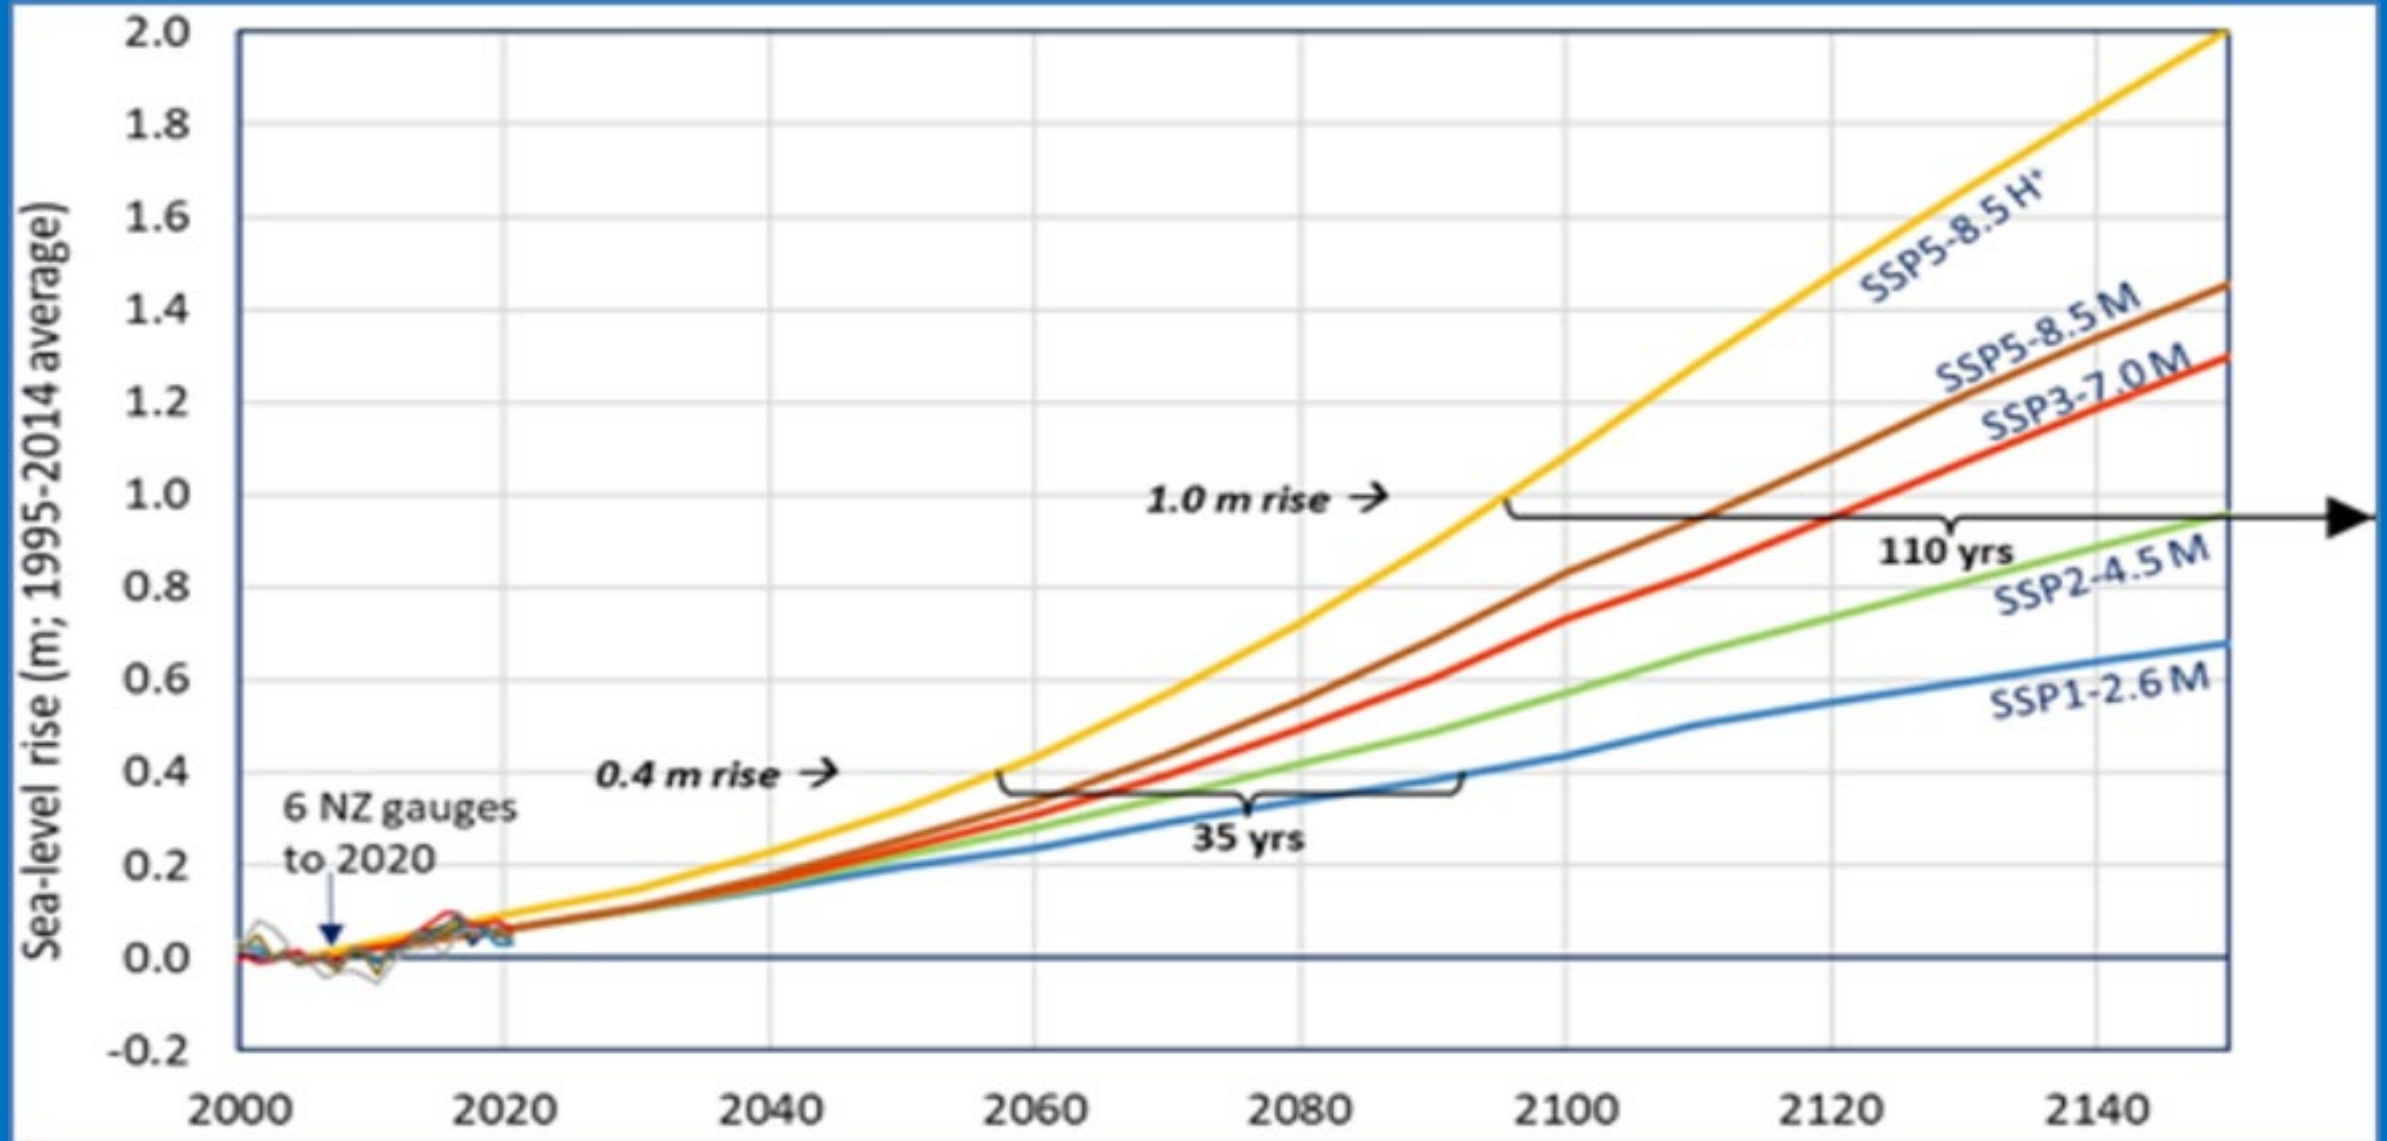
NZ Sea-Level Rise Projection Scenarios to 2150

However, with future projected sea level rise it will progressively become more significant

As a rough initial guide for Russell Beach assume 10m erosion for each 1m sea level rise

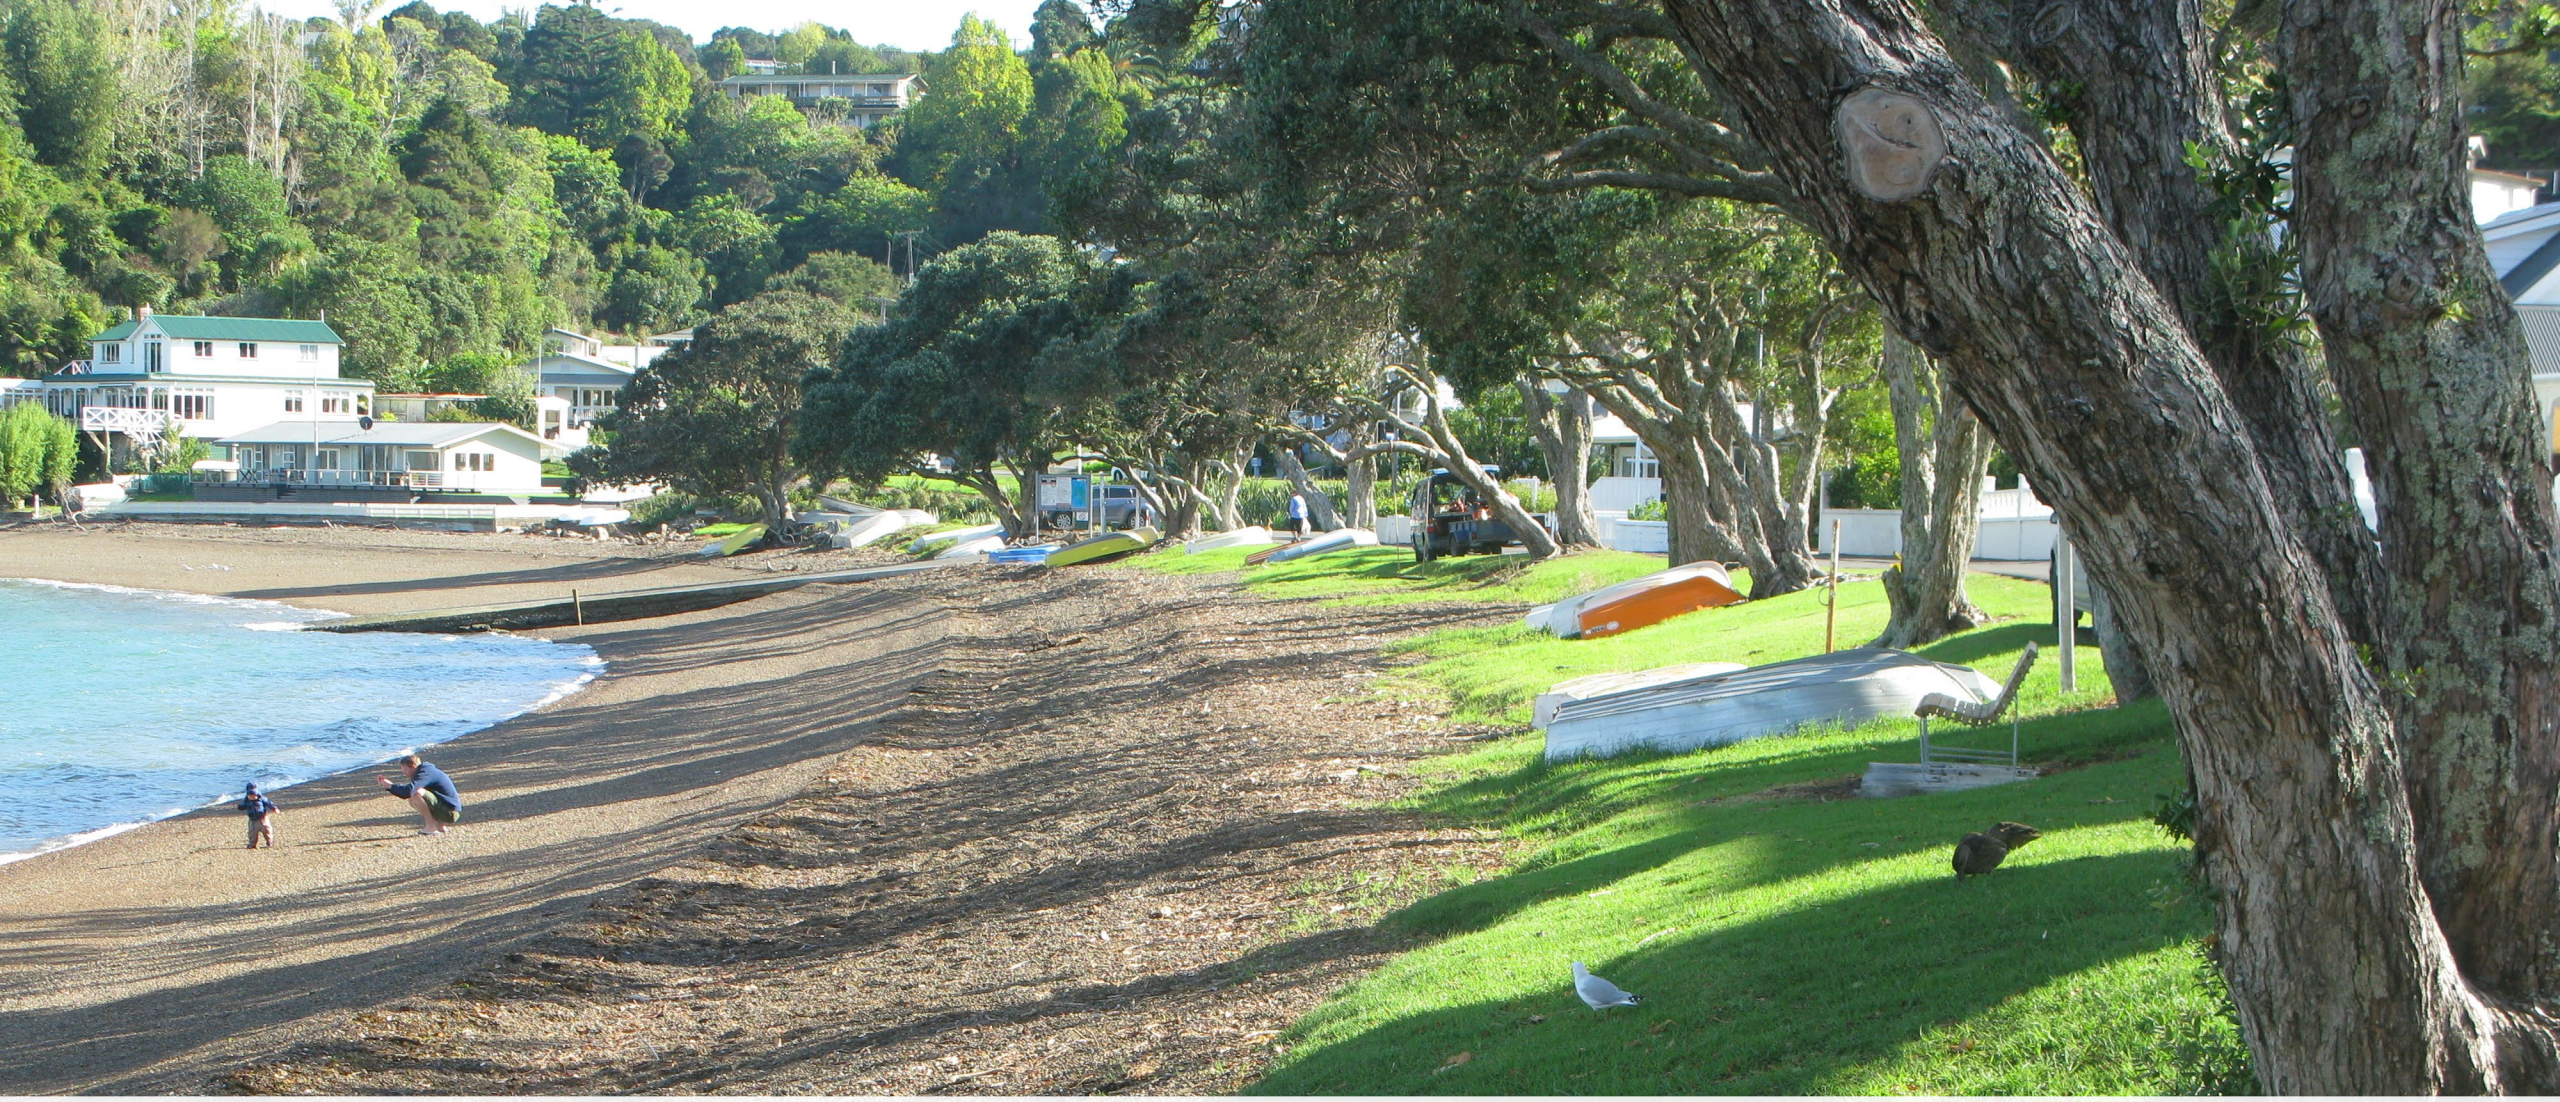
2015 – North end – Beach + Ridge

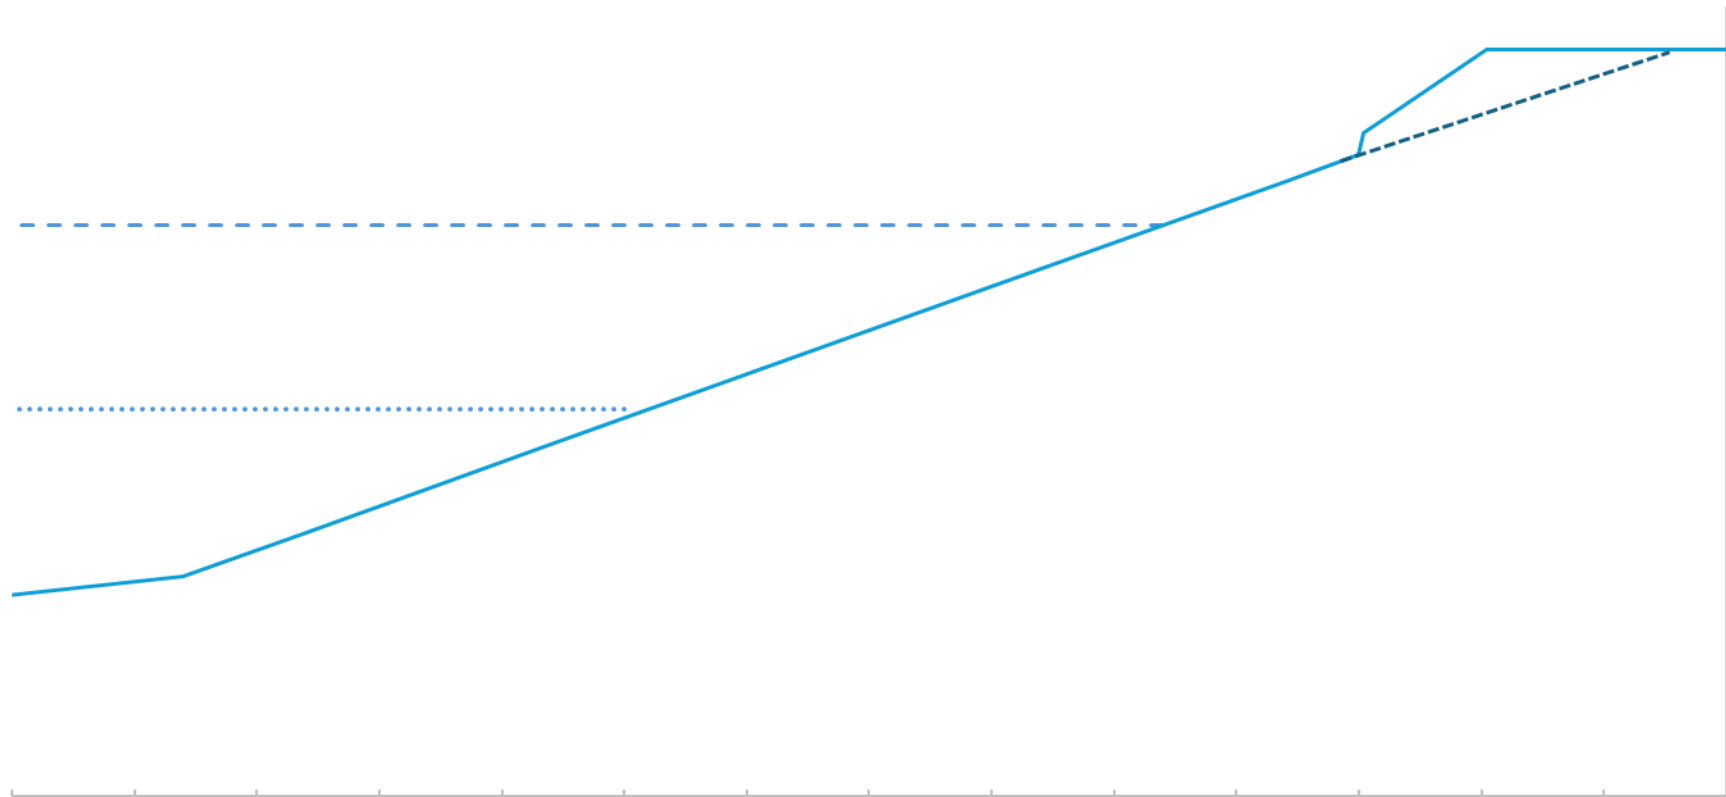
Typical Cross-Section - SKETCH ONLY

- A more landward storm ridge - formed by rare and severe storms (often vegetated)
 - These ridges act as a **very effective** natural buffer – dissipating wave energy

- Grassed reserve & The Strand part of a storm ridge (hence natural shape)
 - Now built up higher by humans over time, which has changed behaviour
 - Sand beaches dissipate wave energy quite differently (sediment carried offshore and deposited on bars – rather than carried onshore and deposited on storm ridge)

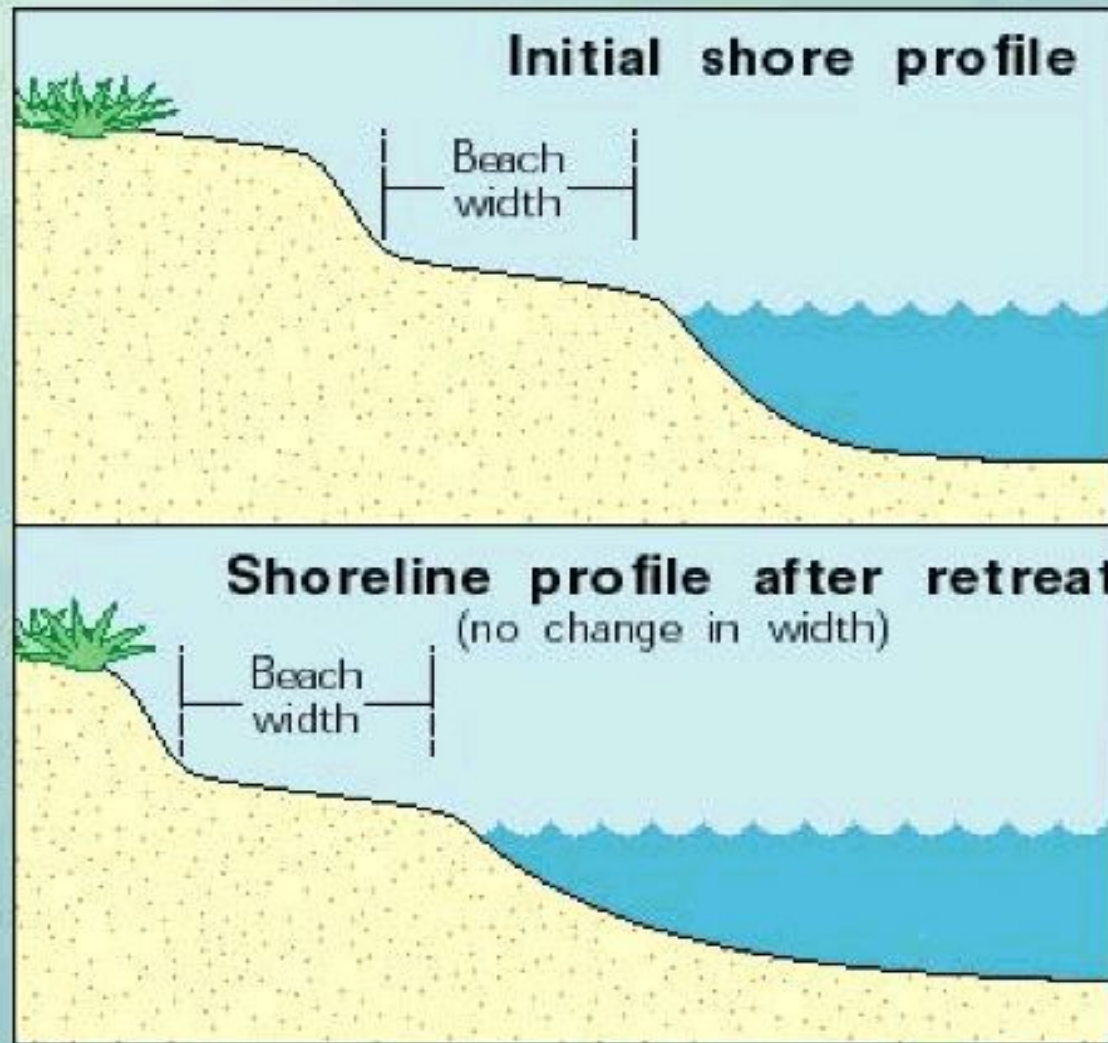
Natural sand beach

Effect of Seawalls on Retreating Beaches

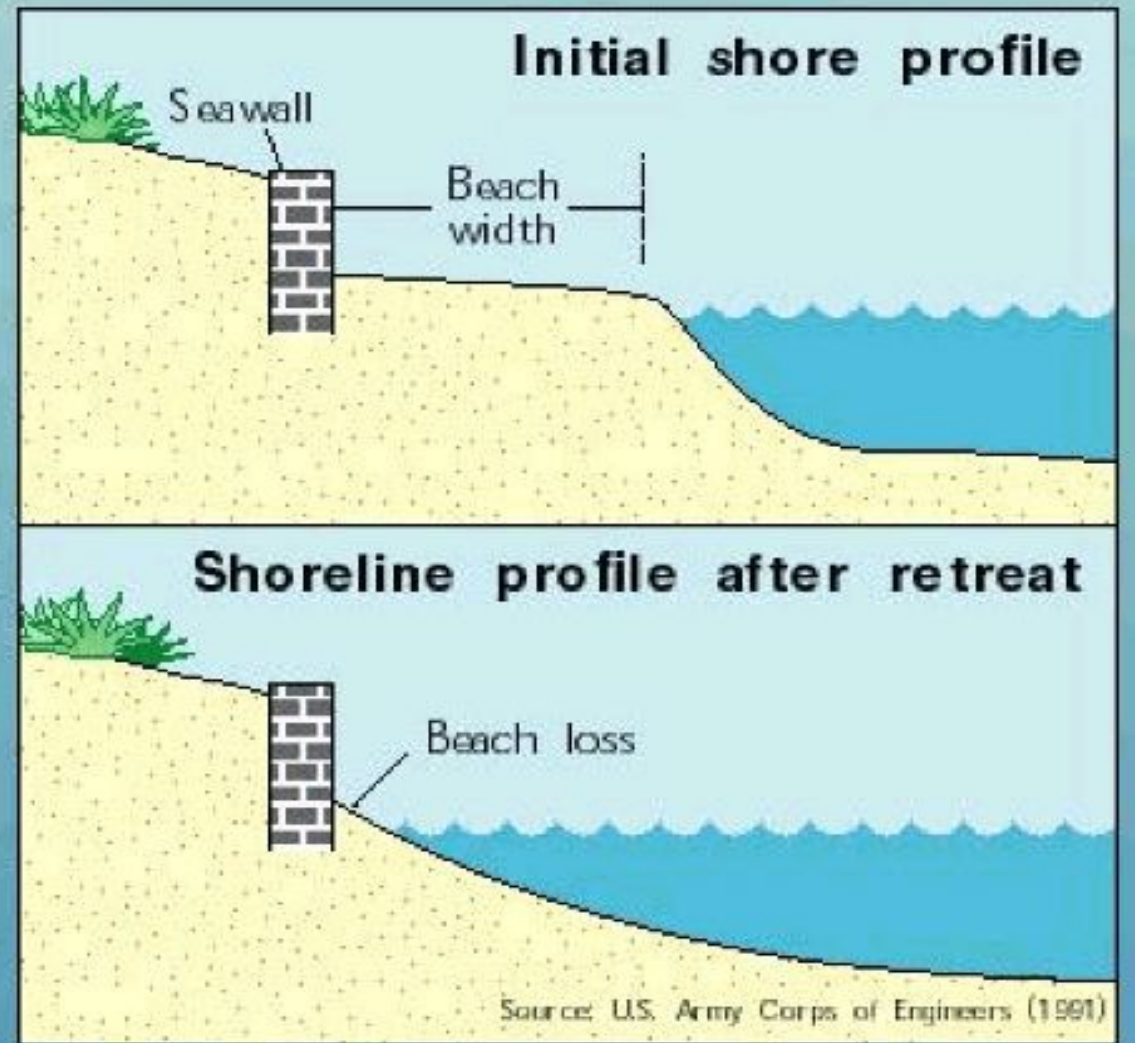
Sea Walls

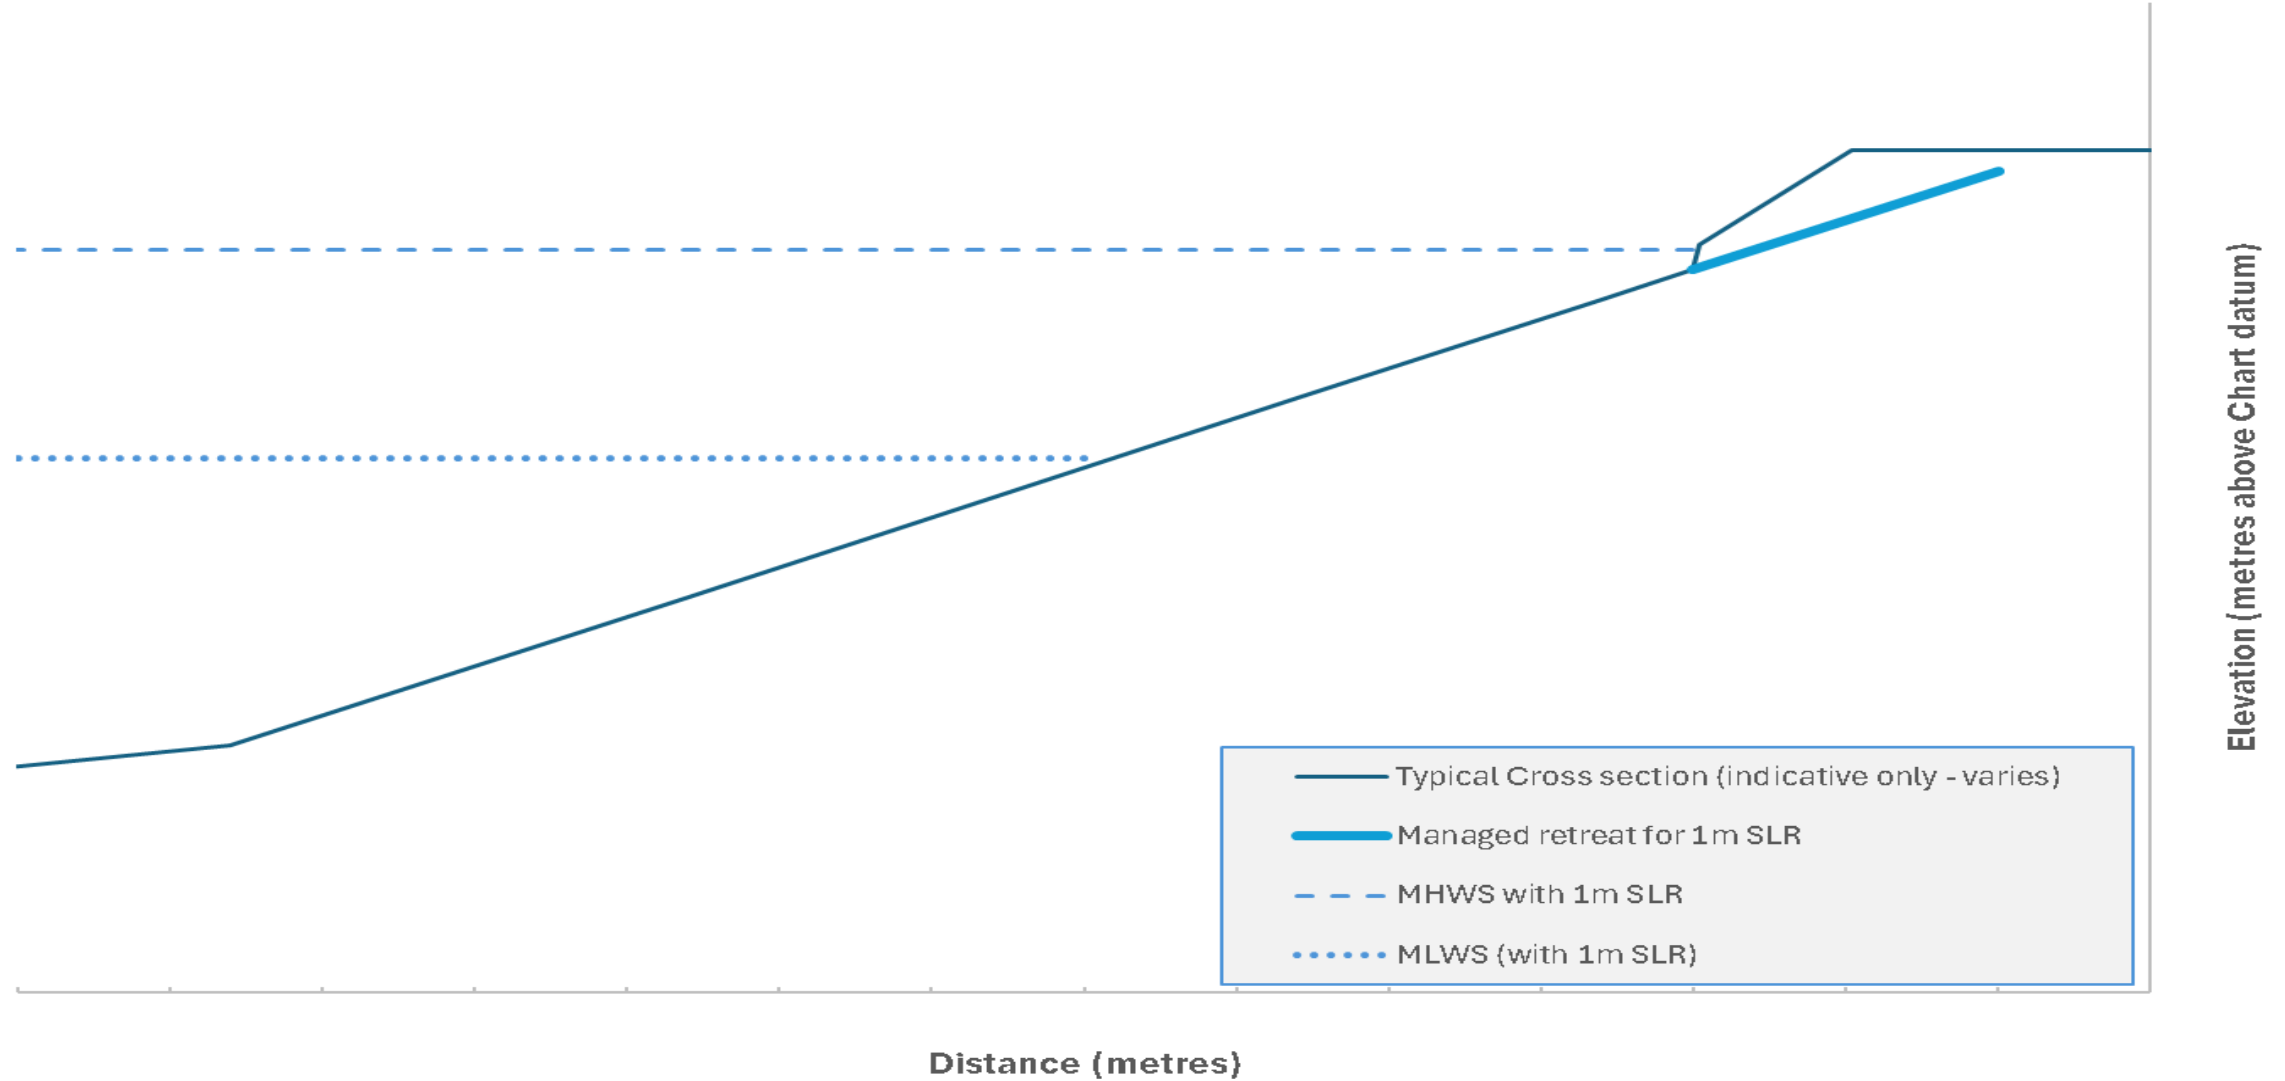
Managed Retreat - SKETCH ONLY

- In the longer term with projected sea-level rise, all options are difficult and expensive
- Managed retreat would eventually require significant landward relocation of existing beachfront development over time
- A well-engineered seawall would protect assets landward of the wall but would result in progressive beach loss over time, eventually requiring nourishment to maintain beach values
- Beach nourishment could potentially offset the adverse impacts of the wall but would require a suitable source of appropriate sediment
- An adaptive management plan would be useful to enable appropriate staged implementation of agreed action over time and ensure the community is aware of the longer term implications of choices

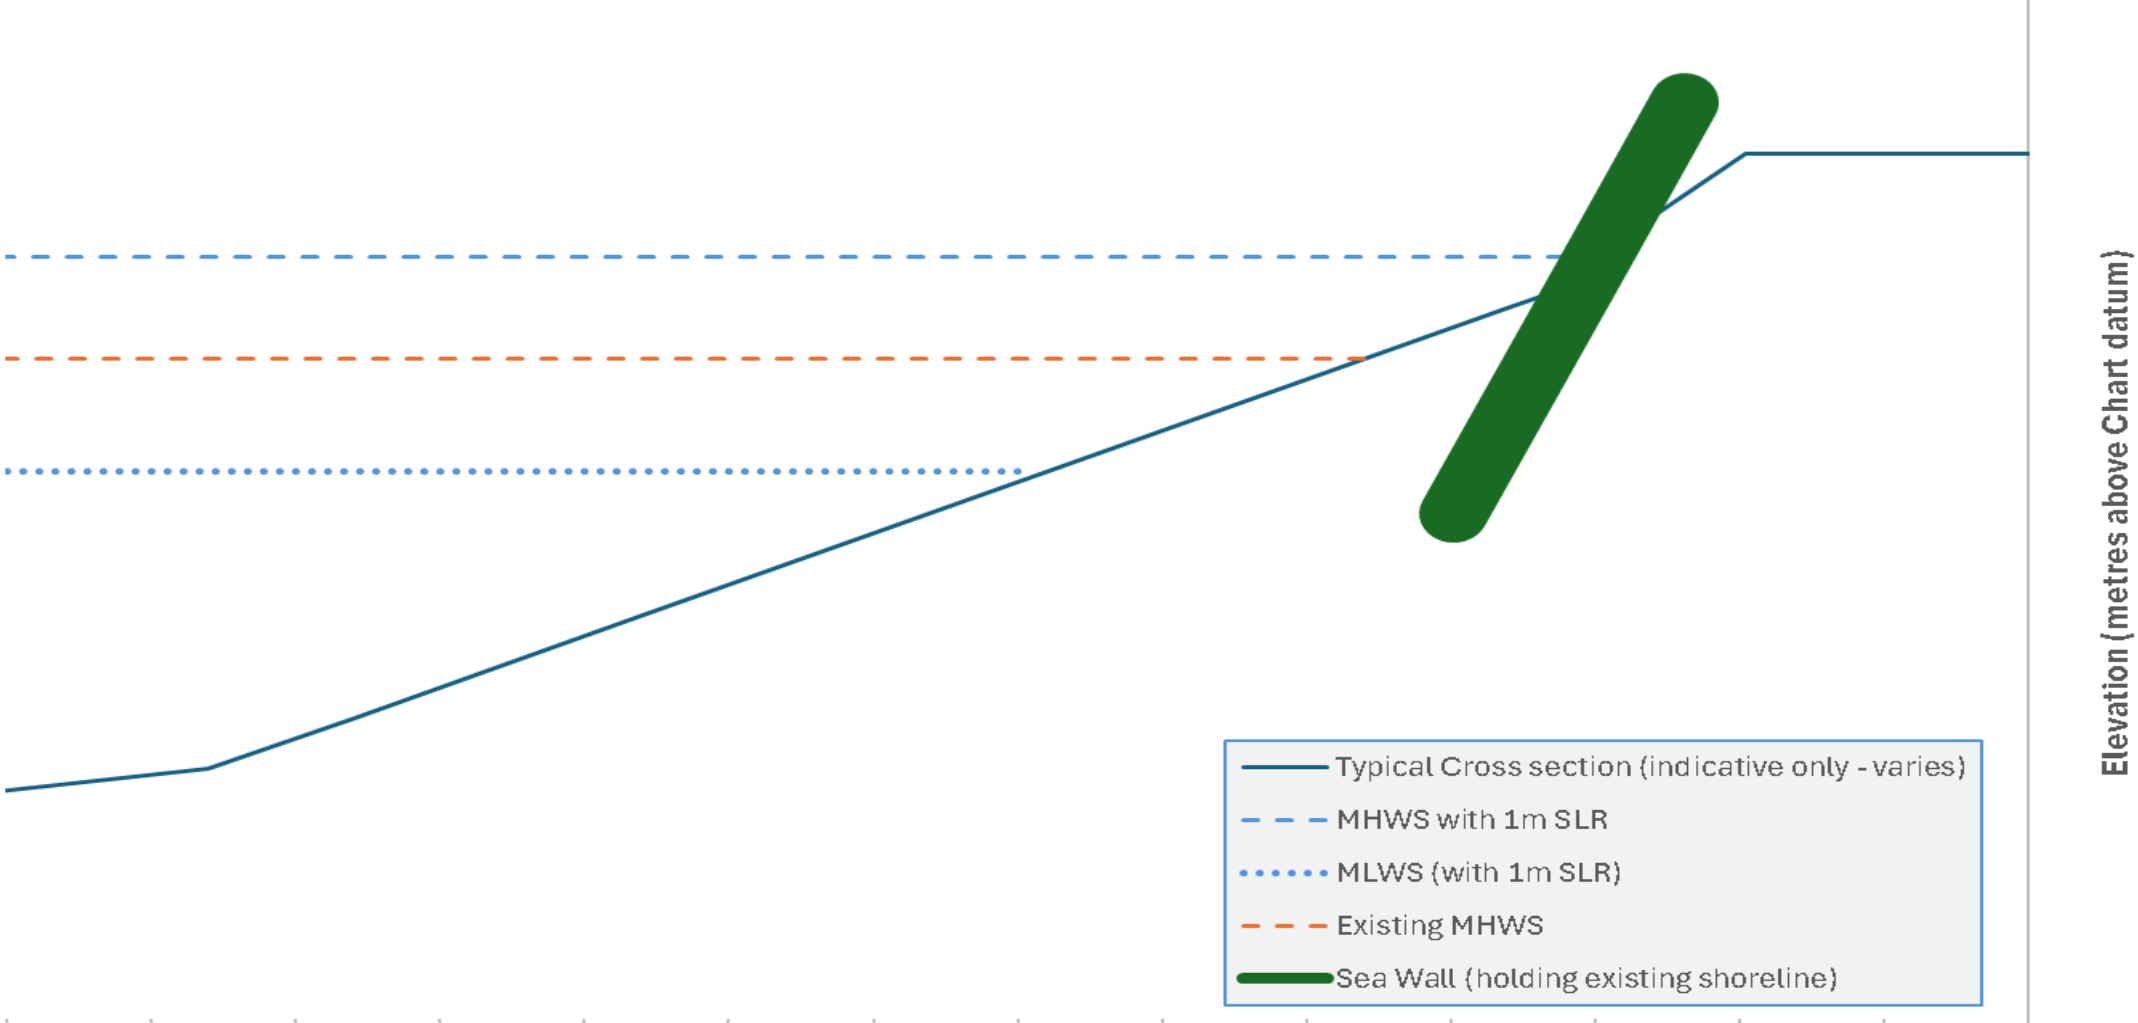
Sea Wall + 1m SLR - SKETCH ONLY

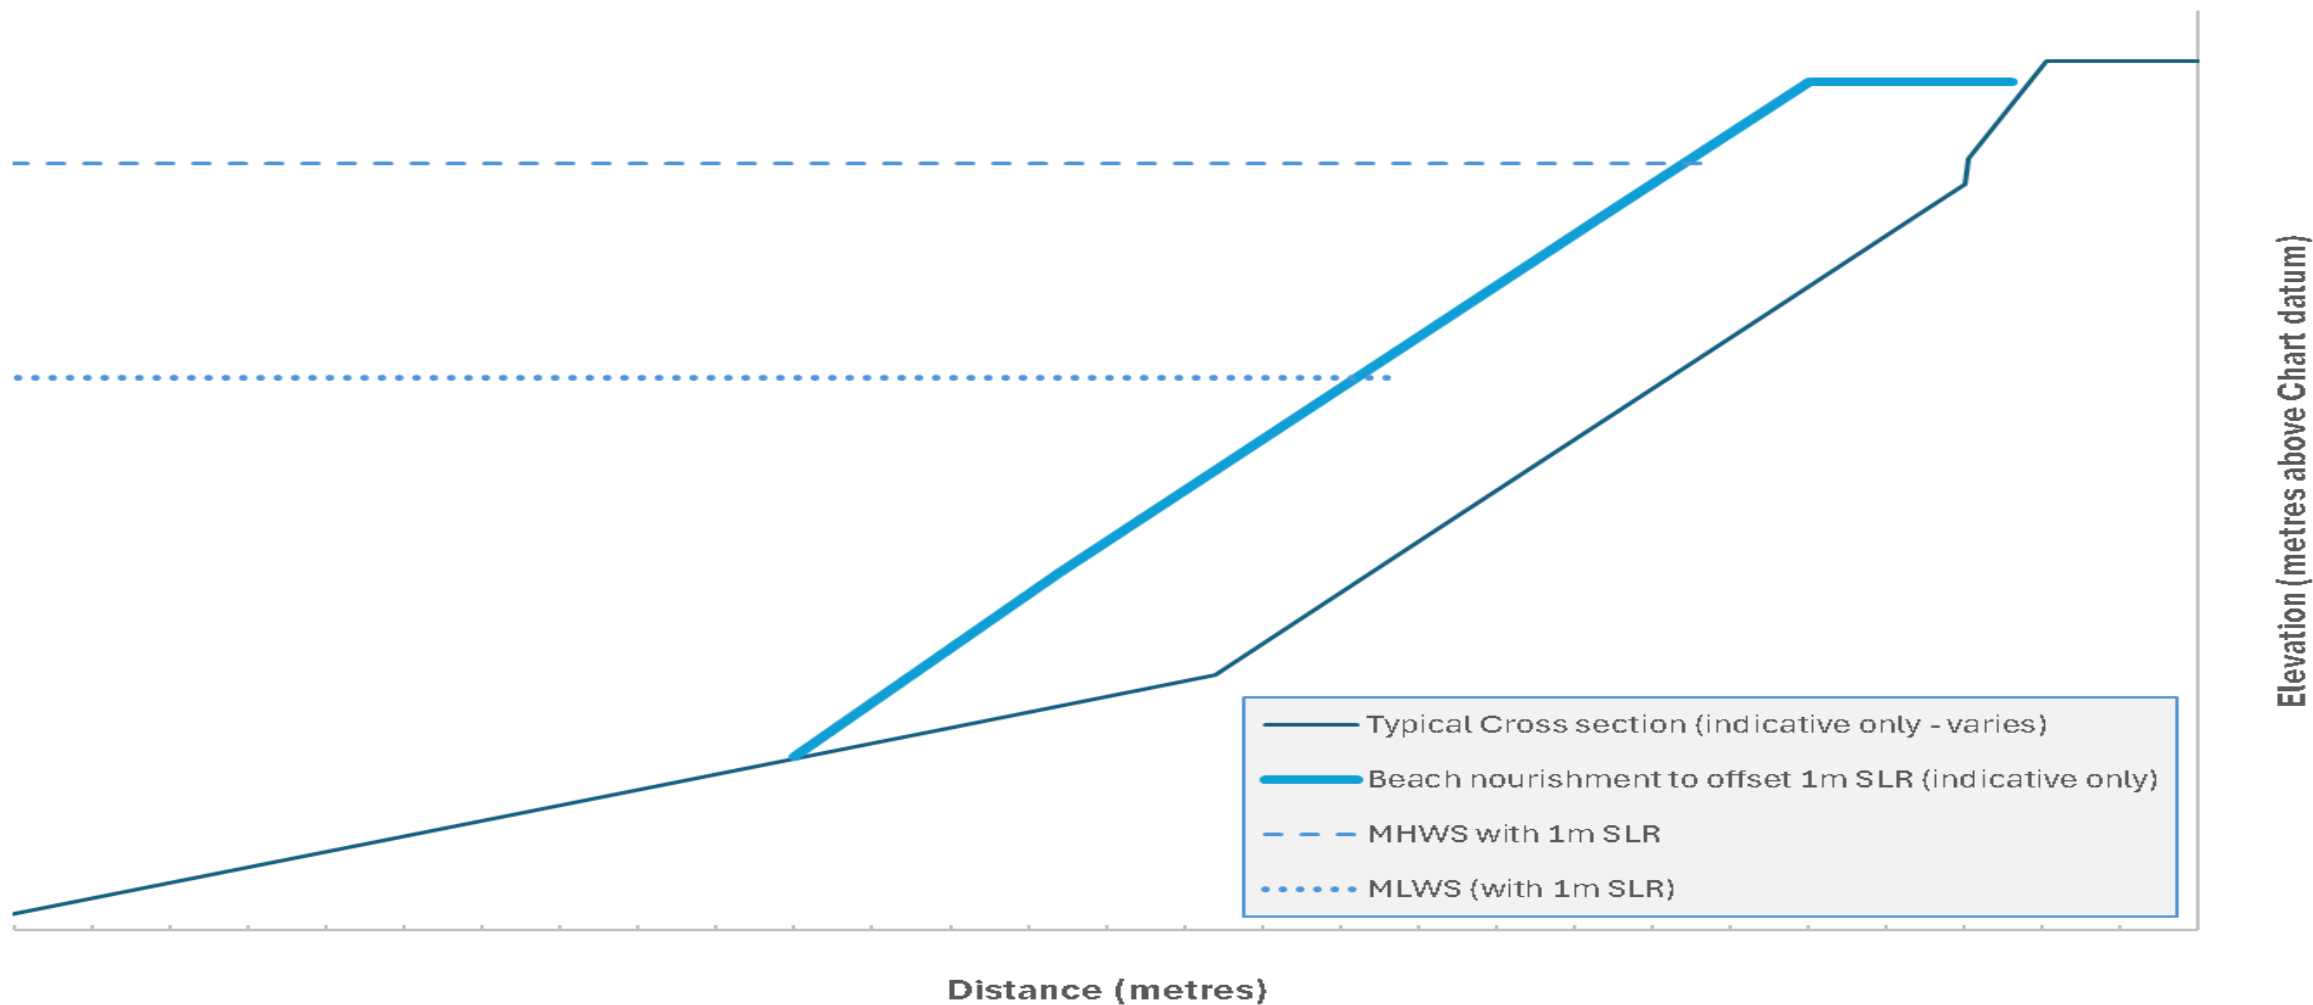
Beach Nourishment to Offset 1m SLR - SKETCH ONLY
